Debris/Ice/TPS Assessment And Photographic Analysis For Shuttle Mission STS-43

September 1991

DEBRIS/ICE/TPS ASSESSMENT
AND
PHOTOGRAPHIC ANALYSIS
OF
- SHUTTLE MISSION STS-43

August 2, 1991

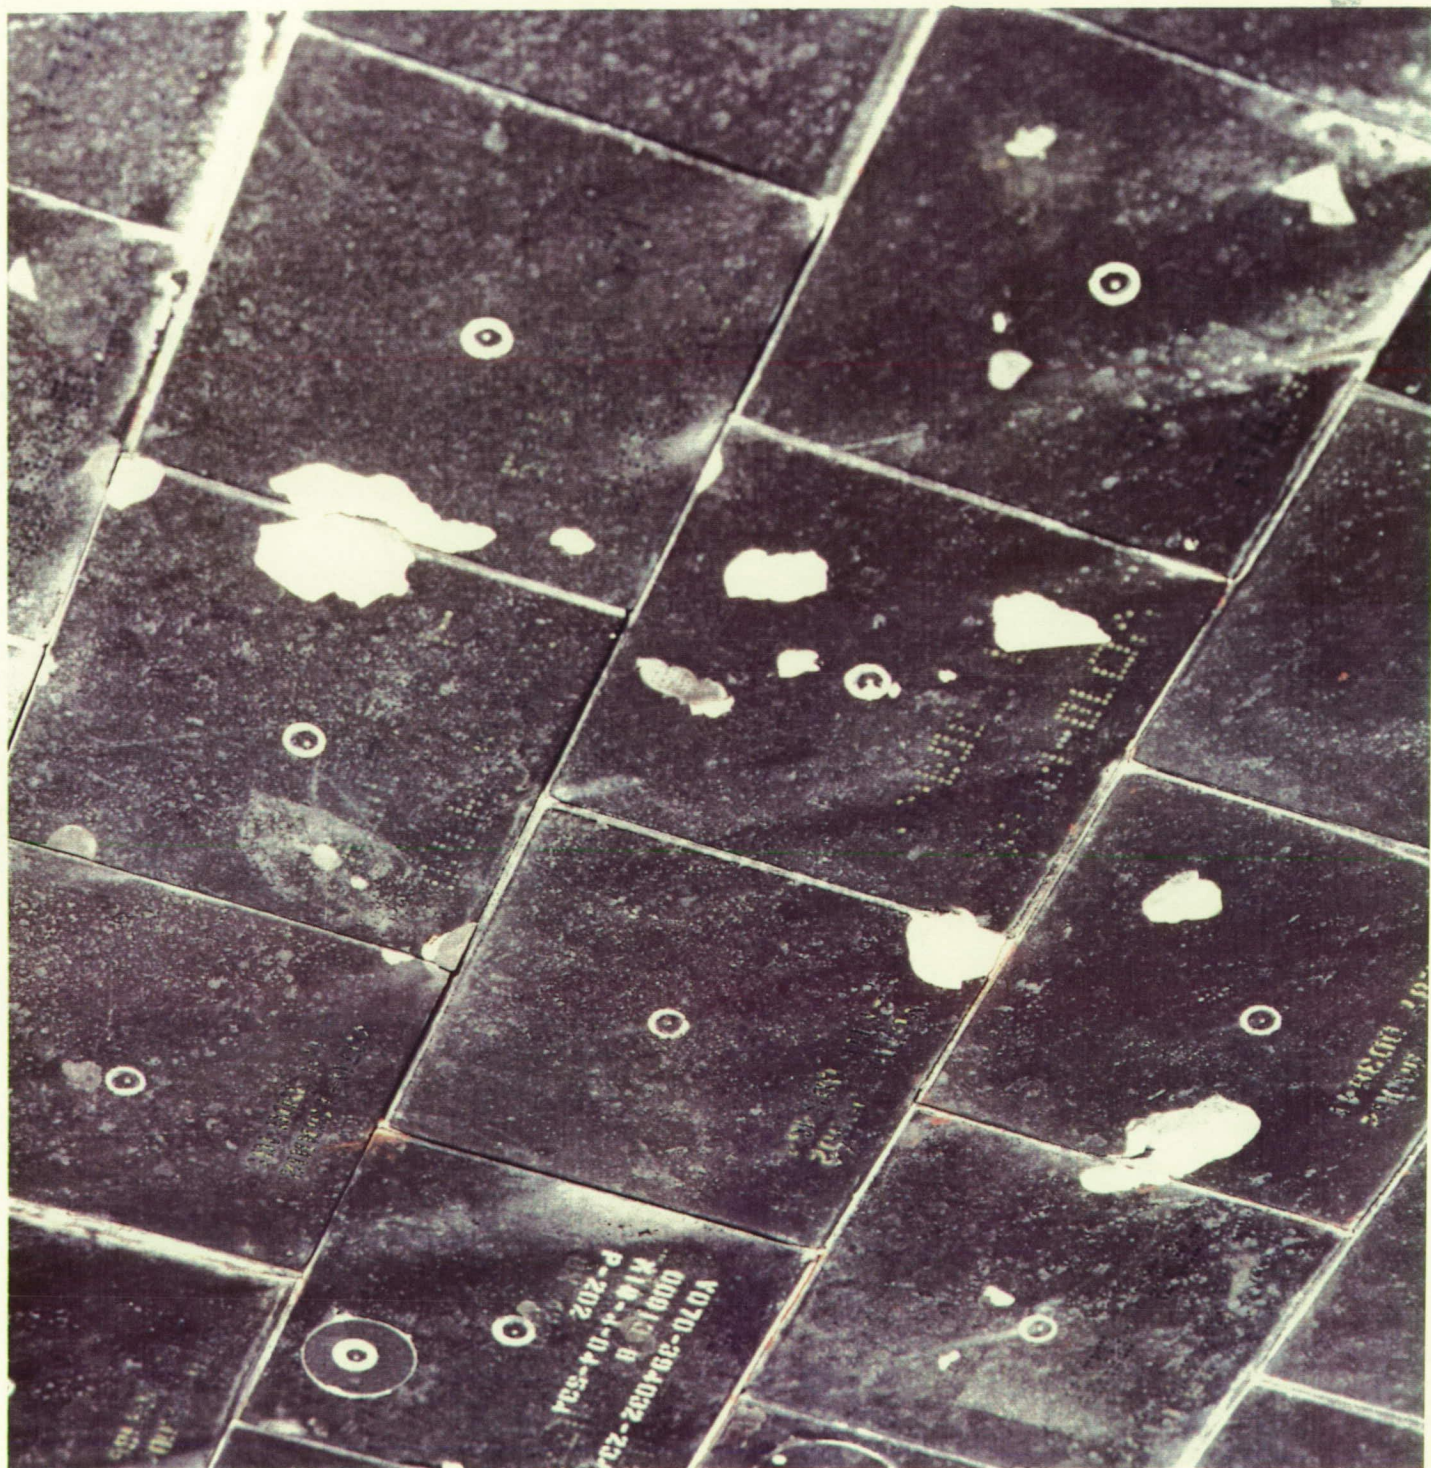
Similar tile damage have been observed forward of the L02 ET/ORB umbilical on previous flights and may be attributed to ice from the L02 feedline bellows and support brackets.

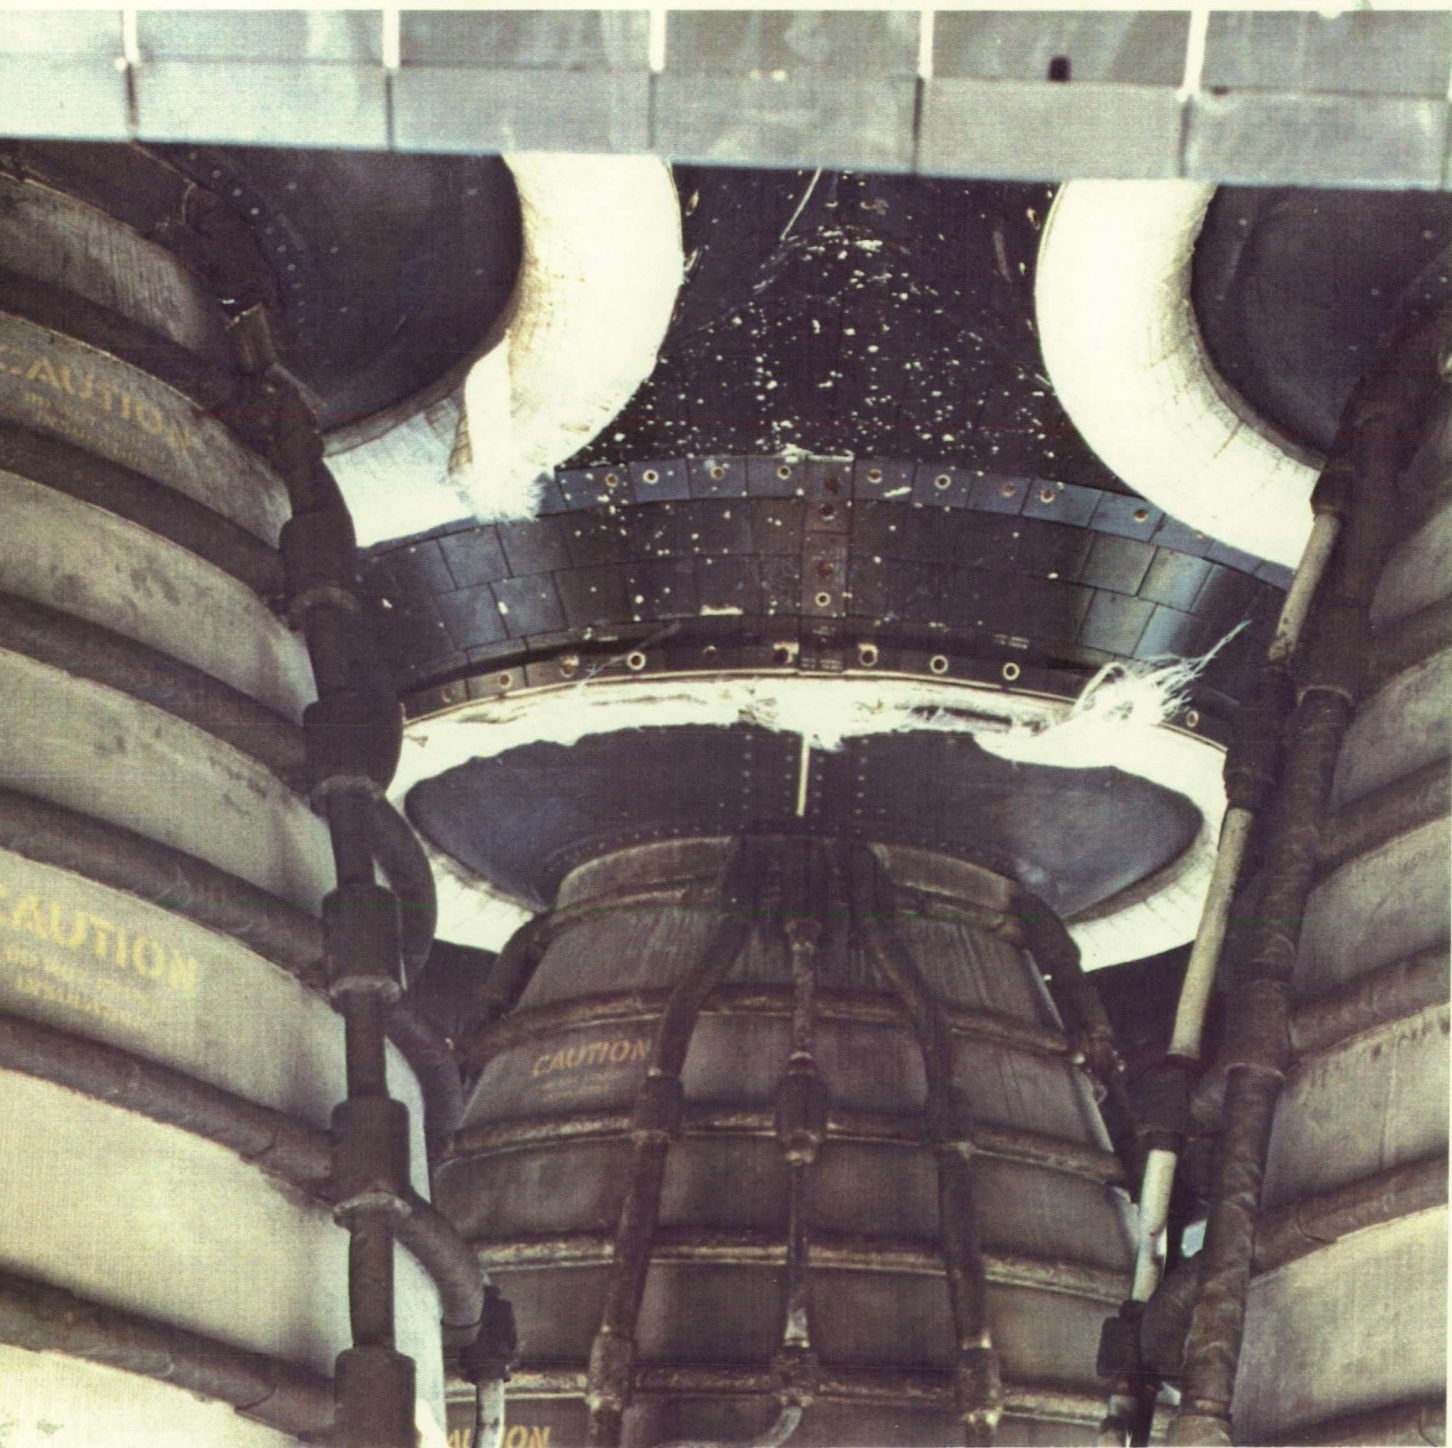
Damage to the base heat shield tiles was average. The outer layer of SSME #3 closeout blanket was peeled back along a 12 inch length at the 10:00 o'clock position. SSME #1 closeout blanket was missing numerous layers of material from the 4-7:00 o'clock position and may have been the white object observed in films falling aft of the Orbiter 43 seconds after launch.

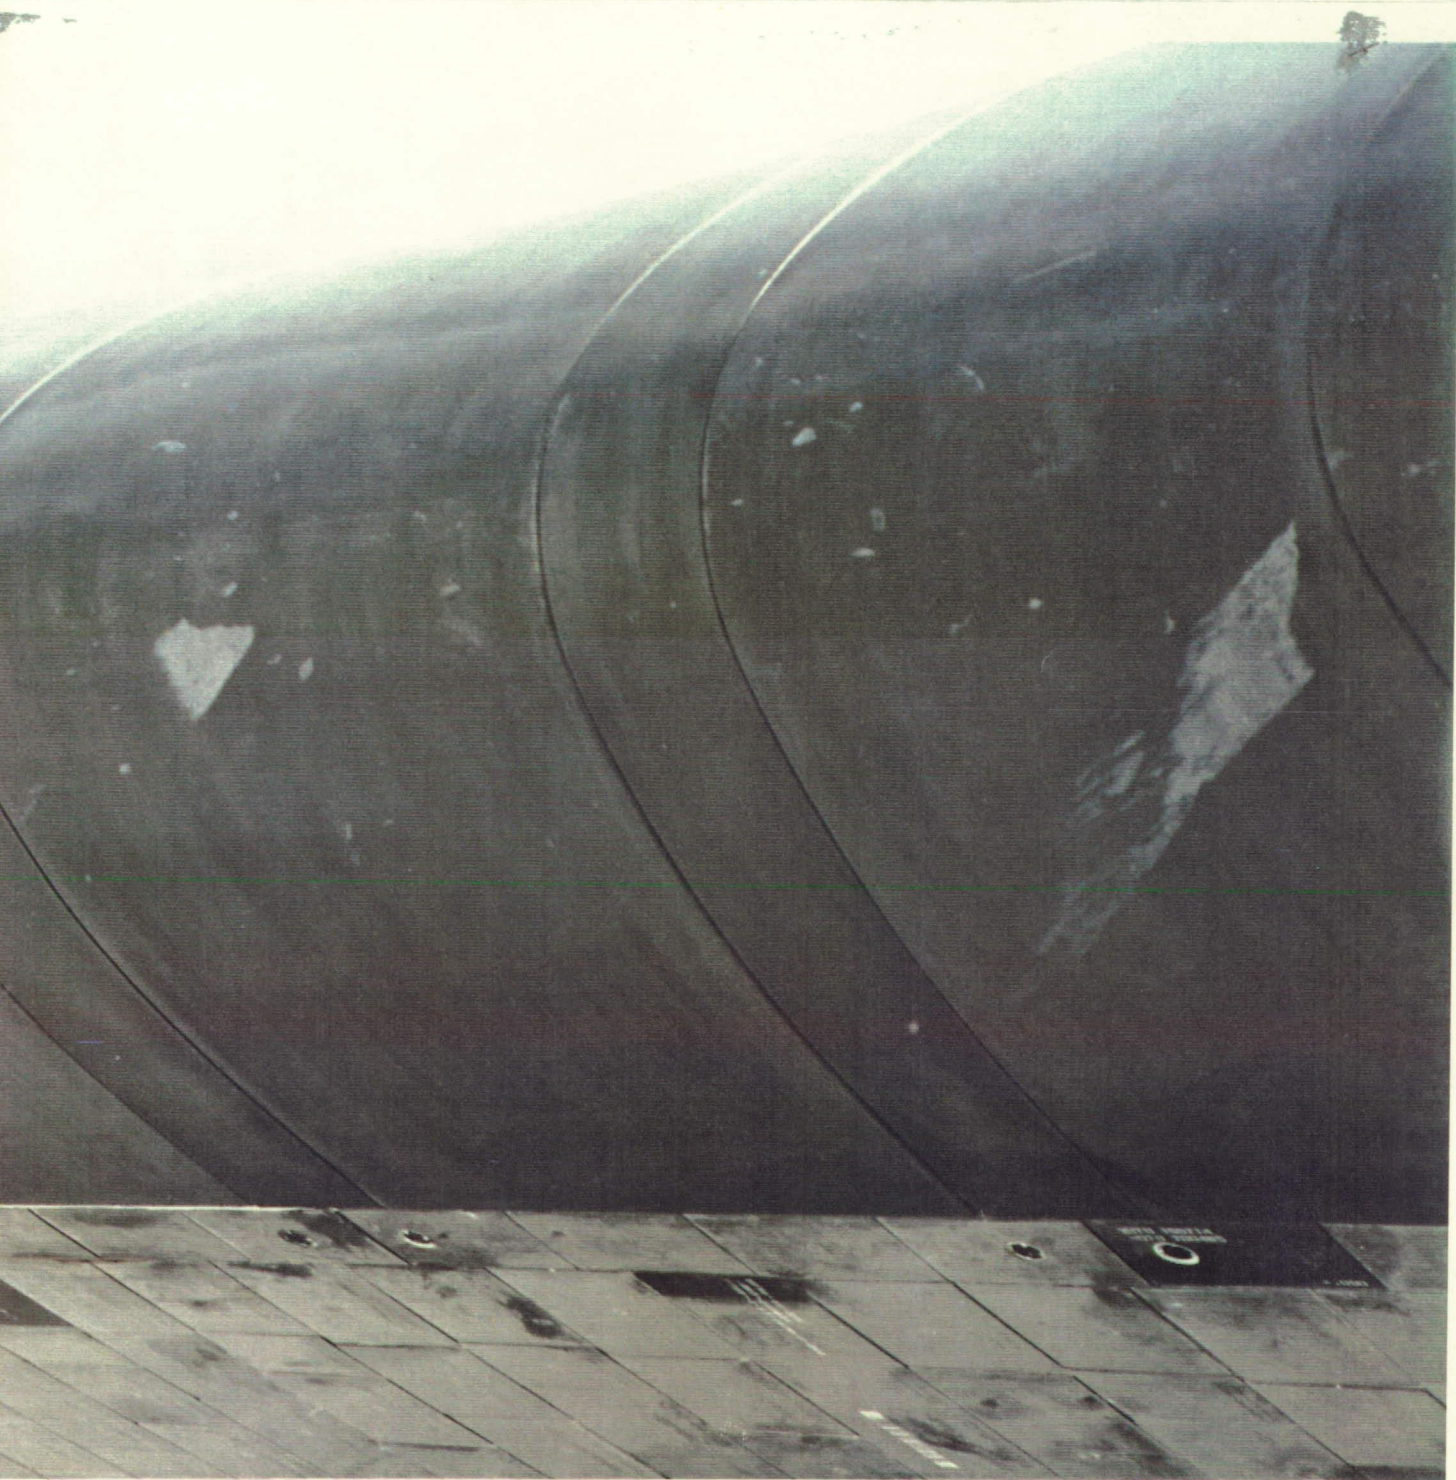
White streaks were present on the RH wing leading edge RCC panels and appeared similar to streaks observed after previous landings.

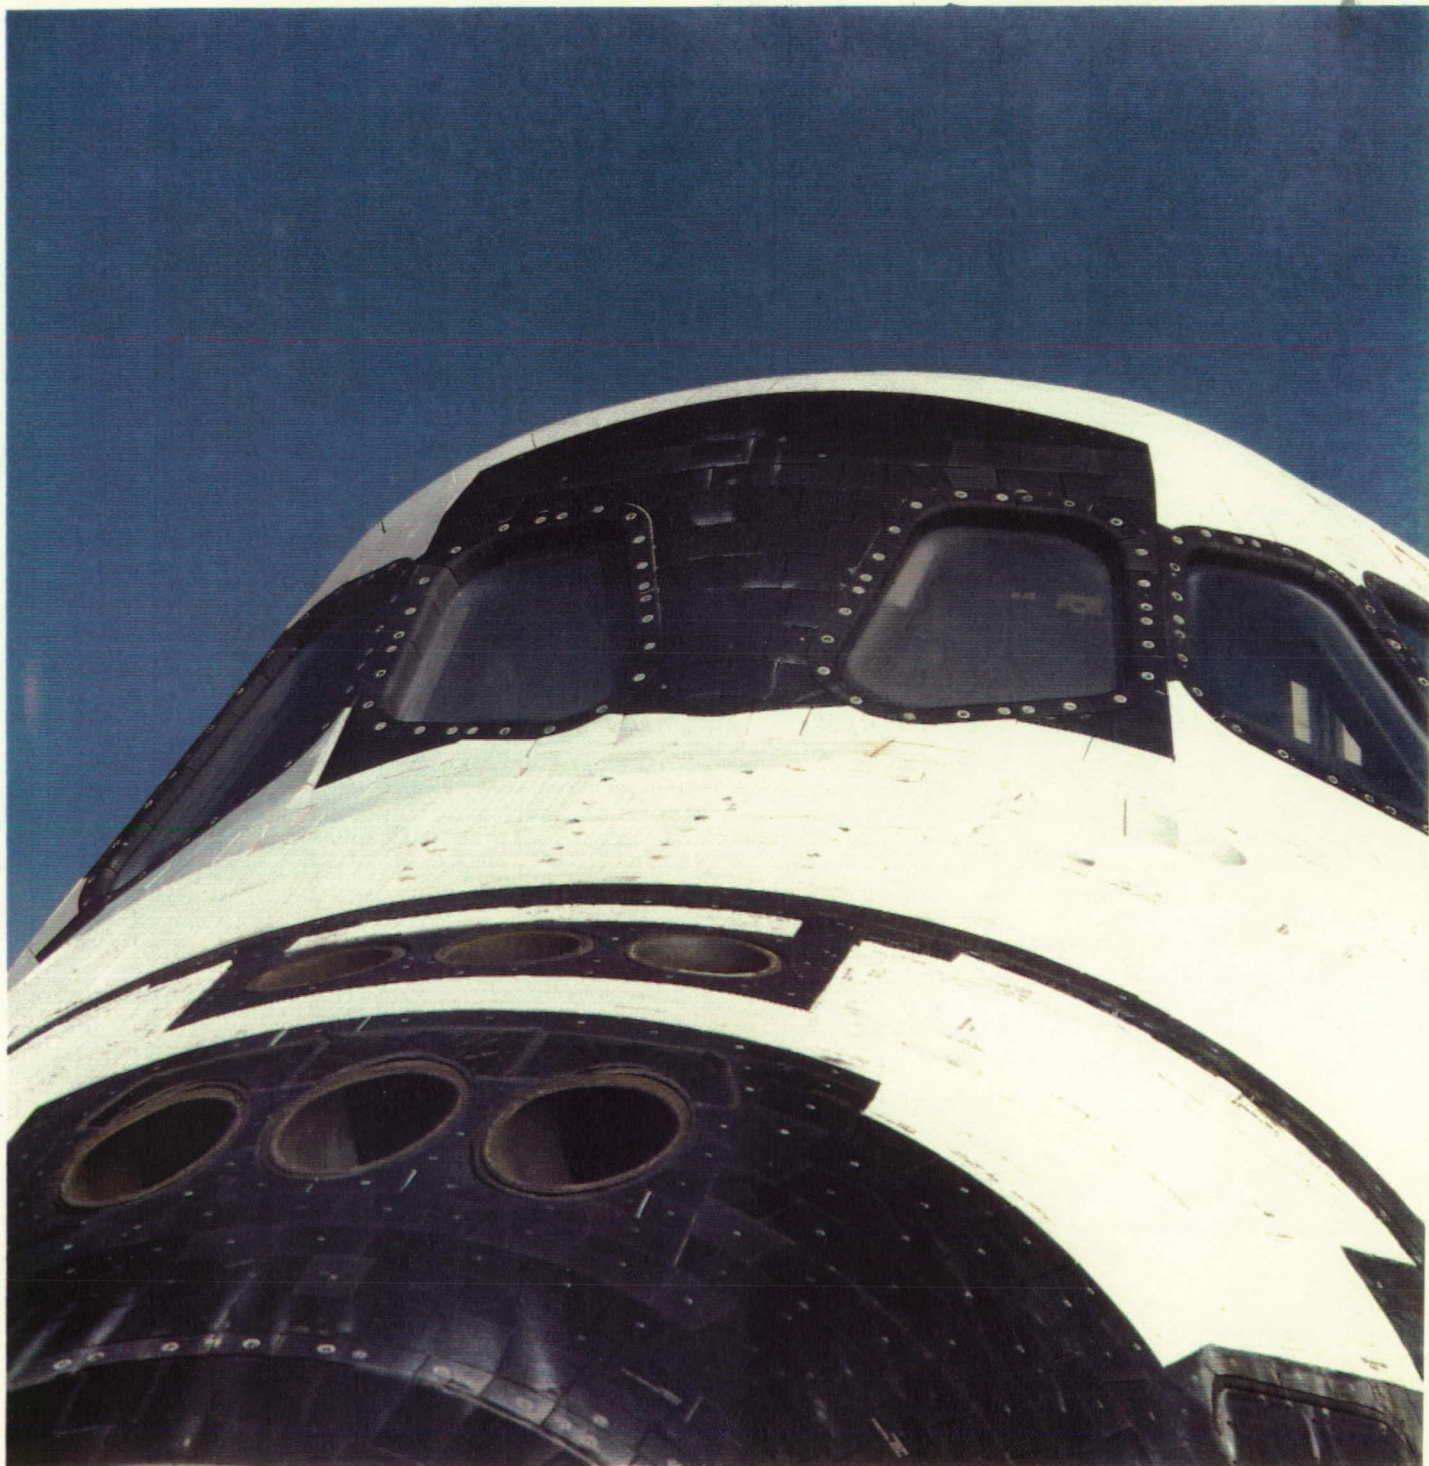
Orbiter windows #3 and #4 exhibited moderate to heavy hazing with a few small streaks. The remaining windows had light to moderate hazing with several small streaks.

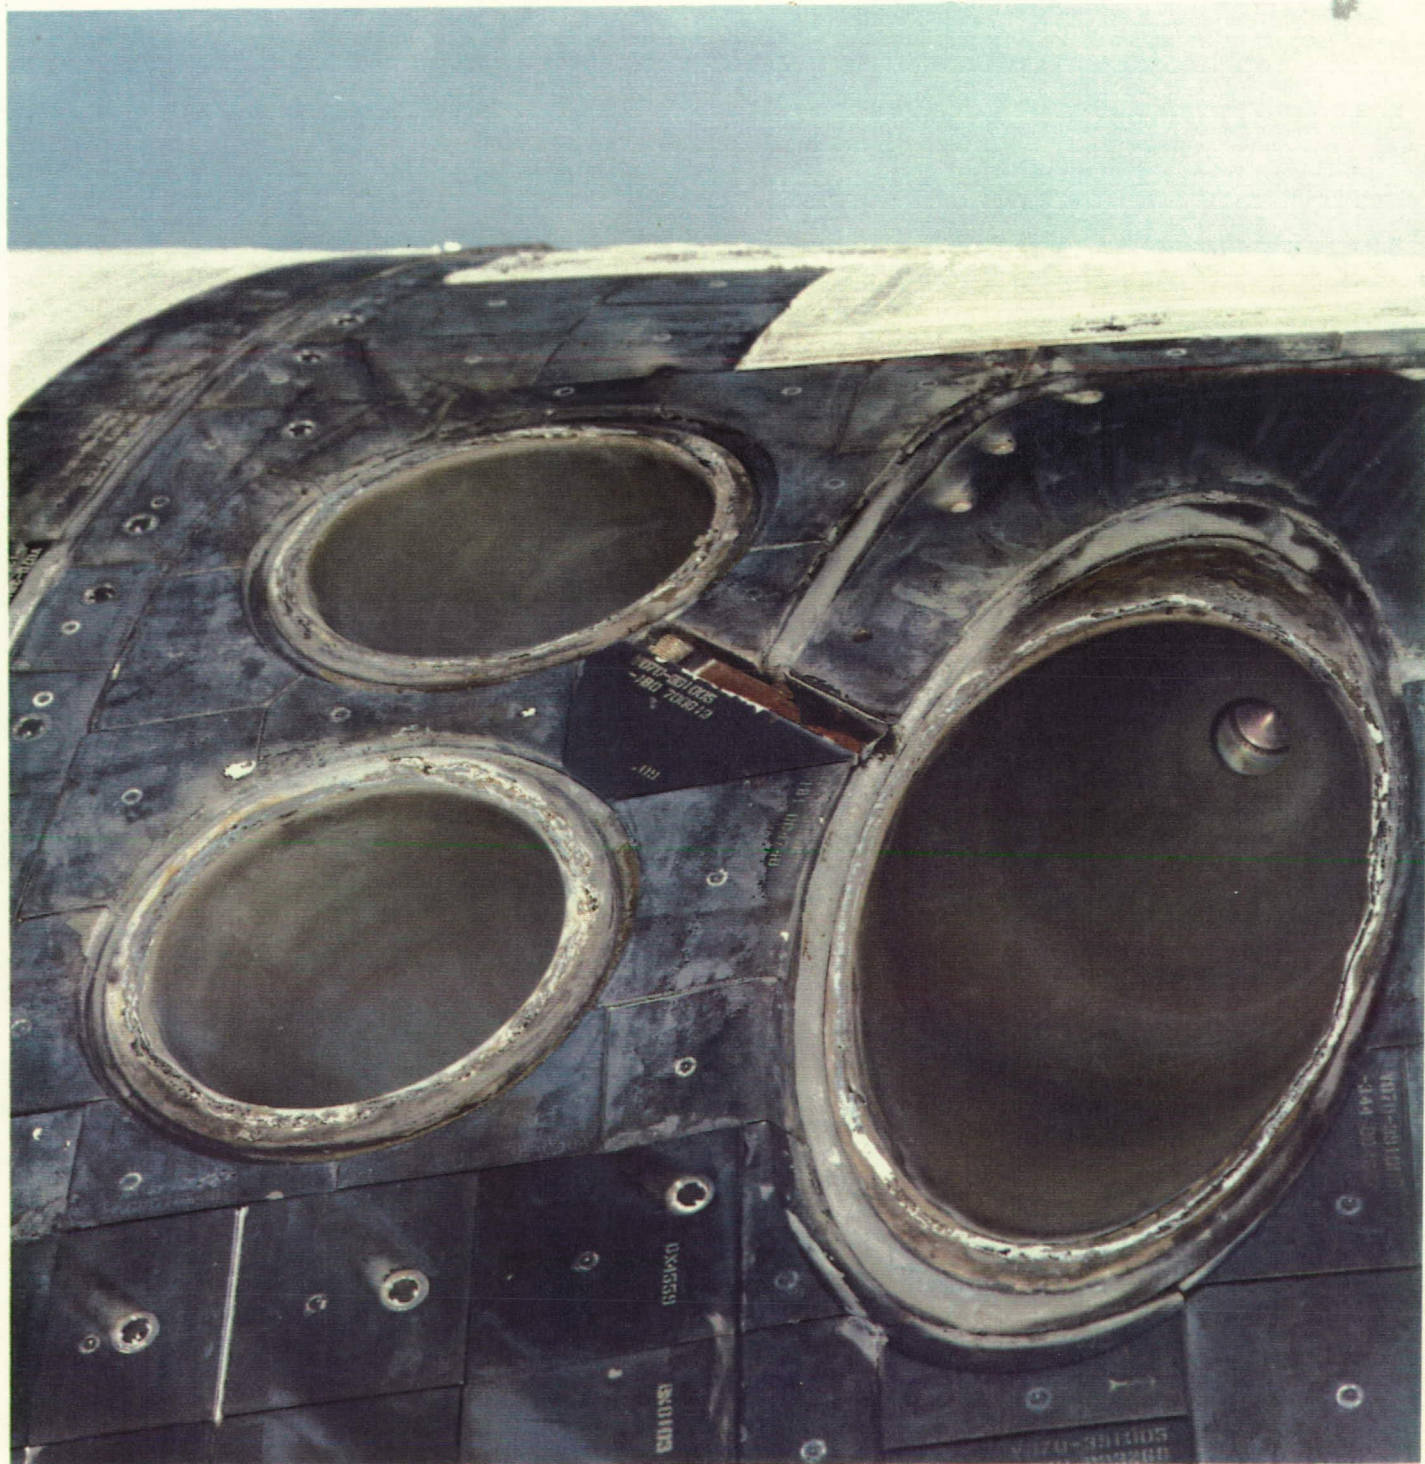
A piece of thermal barrier approximately 8 inches in length was missing from the right side of the forward RCS module between thrusters F2R and F4D.

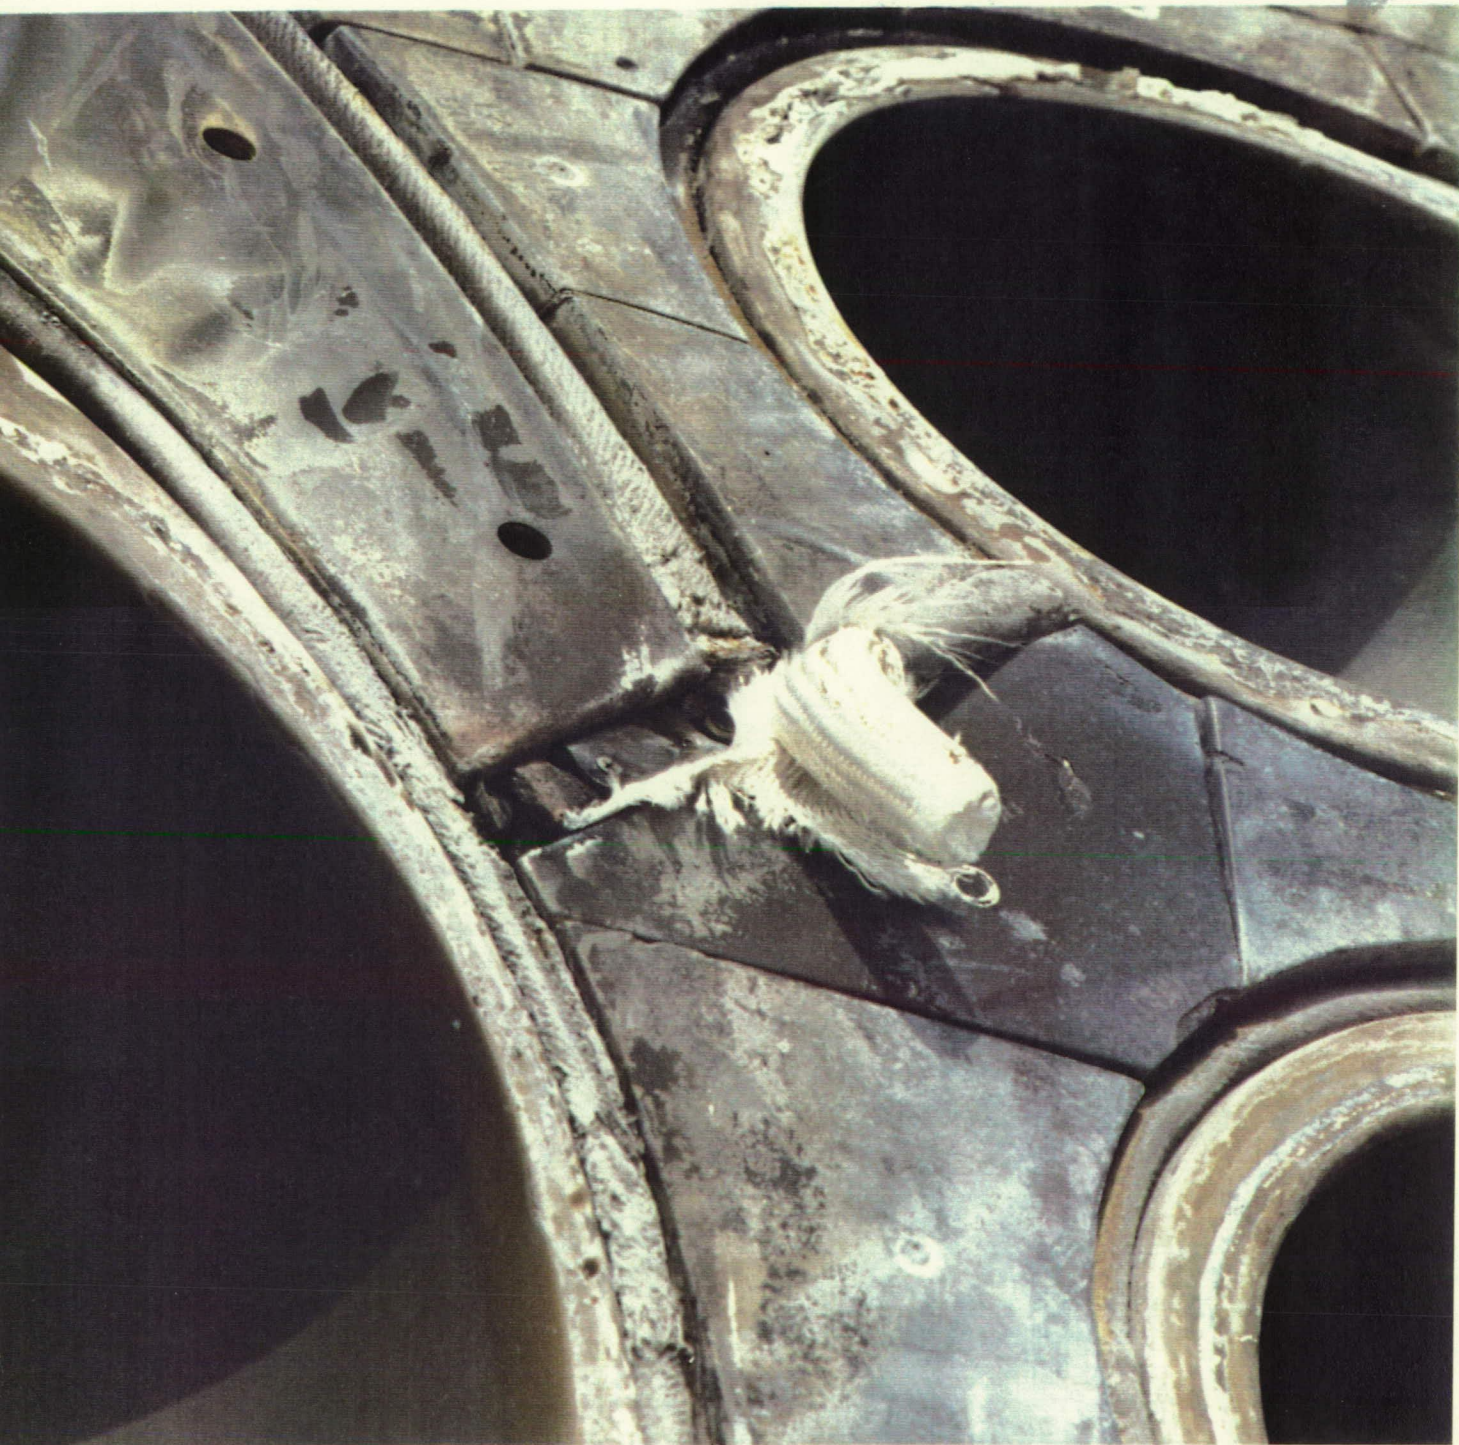
The thermal barrier on the left side of the forward RCS module between thrusters F1L and F3D was frayed and a 4 inch section was protruding.
